# CAVITATION WEAR ON CENTRIFUGAL PUMP IMPELLENTS MADE FROM HASTELLOY C-276 ALLOY

*This article establishes the incidence of the leached liquor in the wear, by cavitation, of impellers of a centrifugal pump. The impeller blades, manufactured from the Hastelloy C-276 superalloy, were analyzed. Eight samples which were sectioned from the upper end of the blade, less affected, to the tip of the blade, more damaged. Through scanning electron microscopy (SEM), pitting, rupture of the passive layer, crumbling of the structure, as well as intercrystalline corrosion were evidenced on the surface. It was observed, in diffractograms, the presence of chlorine (Cl), chemical element that forms chloride ions, which prevents the formation of stable layers of oxides. As a result of this phenomenon, the hardness increased from 225 HV to 270 HV, after the analyzed impellers were removed from service.*

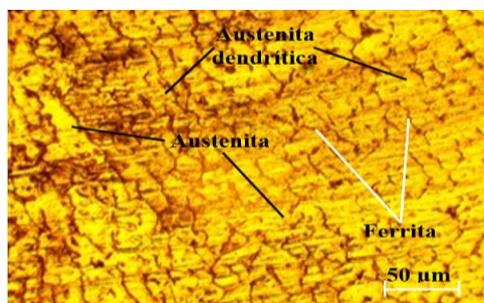
Figure 2. Pump blades structure.

In order to determine the standard microstructure of the blades (Hastelloy C-276), a binocular optical microscope brand NOVEL model NIM-100 was used, equipped with a camera that allows obtaining photos of the microstructure. Figure 2 (samples under conditions of 27 and 34 % of leached liquor) shows a matrix structure with the ferrite in the grain edge and austenite, which is of the dendritic type, which is indicative of a previous treatment to obtain it. These characteristic phases are developed during the smelting process, because the dendrite appears as a result of temperature gradients and originates in the direction of such gradient.

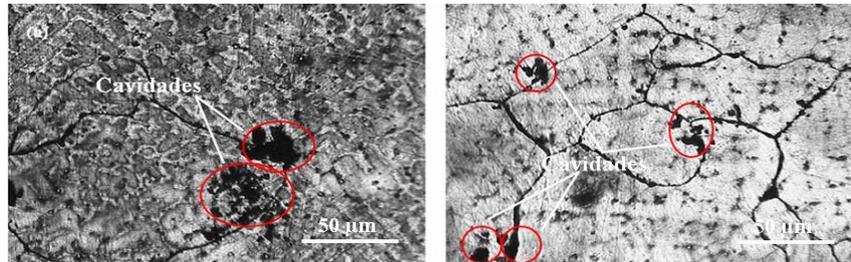
When the cavities is analyzing in the pump blades, it can be seen that, for a liquor concentration of 27 % (figures 4(a) and (b)), the cavitation phenomenon starts with small holes and cracks on the surface, leaving it susceptible due to the effect of the components present in the fluid. While, for a concentration of 34 % (Figures 5(a) and (b)), this defect increases with greater intensity, in the matrix the holes and cracks occur all along the grain boundaries. As the liquor concentrate increases, so do the cavities in the impeller blades, leading to deterioration of the crystalline structure of the alloy.

Figure 4(a) and (b). Blade surface cavities for 27 % concentration.

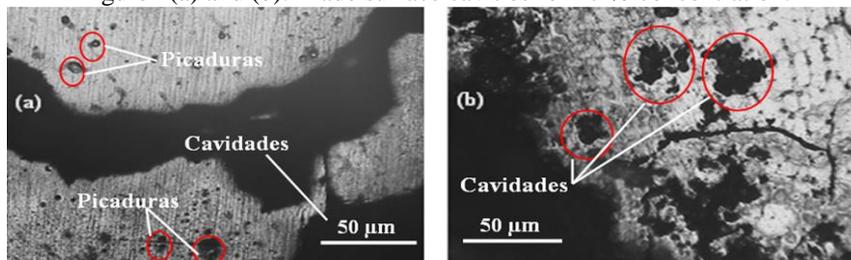
Figure 5(a) and (b). Blade surface cavities for 34% concentrations.

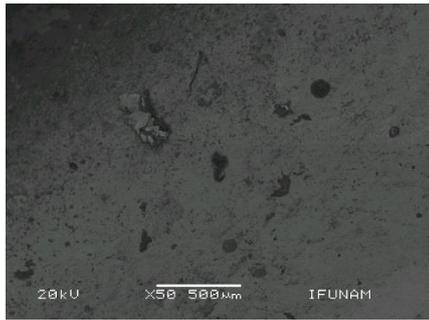
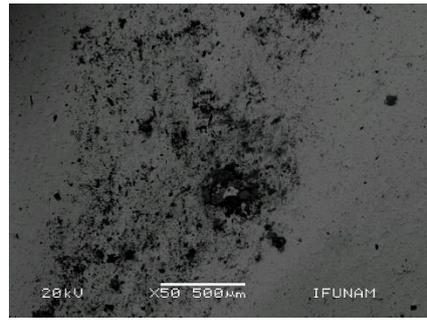
The behavior obtained, by means of SEM, figures 6(a) and (b), correspond to a 27% concentration on the surface of the Hastelloy C-276 super alloy, which shows a lower incidence of cavitation. Regardless of this condition, there is a damaged structure with the formation of pitting and the breaking of the passive layer, with the presence of carbides. The fluid has caused a widespread attack by the effect of intercrystalline corrosion, with the presence of cracks along the grain boundary. There is a line of grains that show crumbling, which weakens the passive layer and the mechanical resistance of the material.

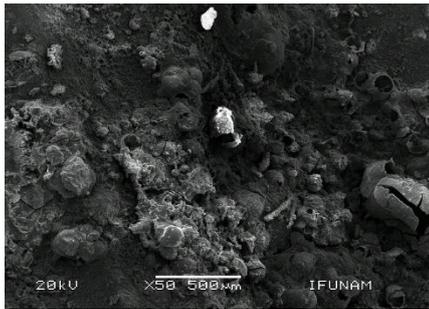
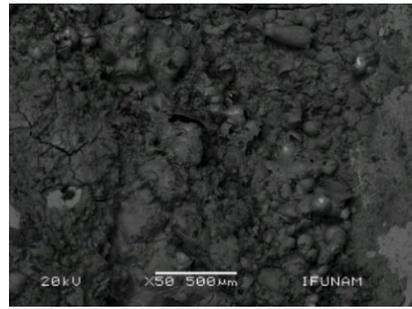
For 34 % concentration in the fluid (figures 6(c) and (d)), the material shows a more deteriorated surface with the presence of pores, cracks and carbides, there is a deformation of the dendritic phase and a non-textured matrix. The formation of the dark shade present on the surface, can be associated with the incrustations of the liquor in the grain boundaries, which leaves it susceptible to superalloy, giving rise to the phenomenon of cavitation.

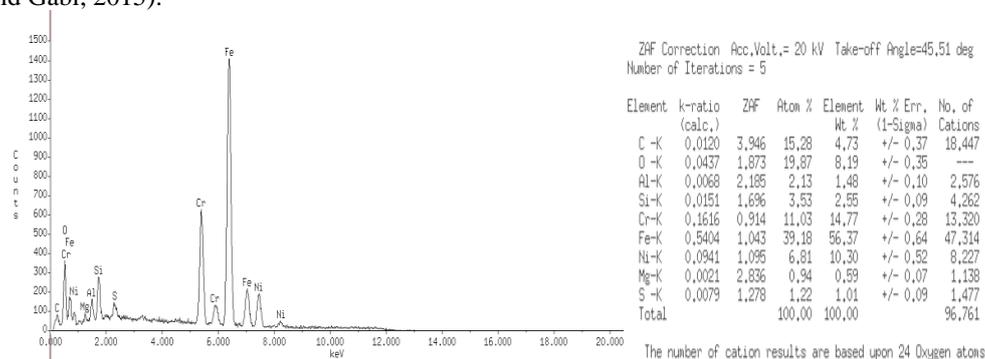
Figure 7(a). SEM for 27 % solids concentration in the fluid.

The SEM standards obtained in the different samples (Figure 7(a)), correspond to 27% of concentration and 7(b) to 34 %. An angle of 45.51° was used to obtain the diffractograms. It is observed that, there is a variation in the chemical elements, as the fluid interacts with the surface of the Hastelloy C-276 superalloy, the components of this hydro mixture leave the material susceptible to the phenomenon of cavitation, the bubbles influence the durability of the impeller. The presence of oxidizing or reducing substances, traces of CO<sub>2</sub> and organic substances in the solution can change this character and make the steels active or passive. There is a surface hardening as a result of the successive impacts of the shock waves that produce the appearance and implosion of the vapor bubbles generated by the cavitation process, which favors localized transformation with low levels of effort (Mittag and Gabi, 2015).

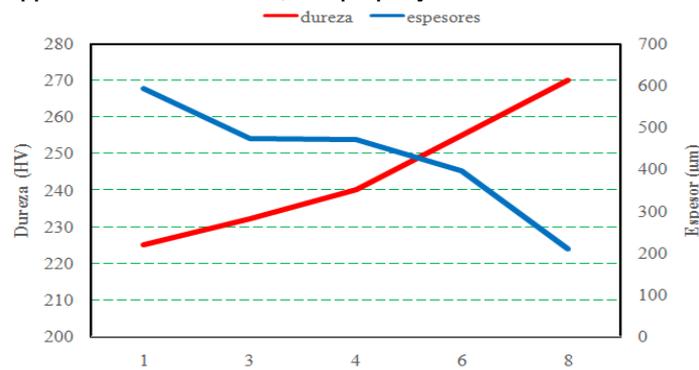
Figure 8. Hardness vs. thickness behavior.

When evaluating the hardness behavior in relation to the thickness in one of the worn-out blades removed from service (figure 8), it can be seen that, for an initial value of 217 HV, in the Hastelloy C-276 superalloy, it increased to 225 HV at the upper end of said blade, a matter that is little affected by the effect of the implosion of the bubbles, however, as it approaches the lower end, this property increases until it reaches HV 270.

There is an inverse relationship between hardness and thickness, the latter being reduced by the effect of fluid friction on the surface and causing a decrease in grain size due to the effect of pungeny.
