# CAVITATION WEAR ON CENTRIFUGAL PUMP IMPELLENTS MADE FROM HASTELLOY C-276 ALLOY

*This article establishes the incidence of the leached liquor in the wear, by cavitation, of impellers of a centrifugal pump. The impeller blades, manufactured from the Hastelloy C-276 superalloy, were analyzed. Eight samples which were sectioned from the upper end of the blade, less affected, to the tip of the blade, more damaged. Through scanning electron microscopy (SEM), pitting, rupture of the passive layer, crumbling of the structure, as well as intercrystalline corrosion were evidenced on the surface. It was observed, in diffractograms, the presence of chlorine (Cl), chemical element that forms chloride ions, which prevents the formation of stable layers of oxides. As a result of this phenomenon, the hardness increased from 225 HV to 270 HV, after the analyzed impellers were removed from service.*

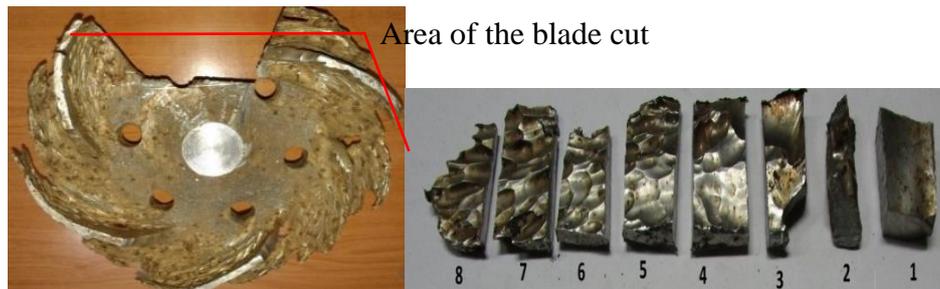
Figure 1. Cut made to a blade of selected samples.

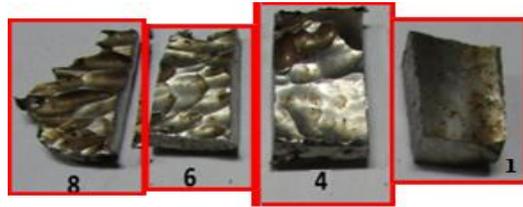
To determine the hardness, 4 blades were finned, as shown in figure 3. These areas were considered, taking into account the incidence of the fluid on them. Of the 8 samples cut, No. 1; 4; 6, were 8 also selected for hardness scanning. These were chosen because, when the bubbles implode, the effect on the blades is not homogeneous.

Figure 3. Hardness measurement in the different selected areas
